## The value of piston rod vibration measurement in reciprocating compressors

by **Larry Leonard**  
Senior Reliability Engineer  
UNOCAL 76 Products Company  
San Francisco Refinery

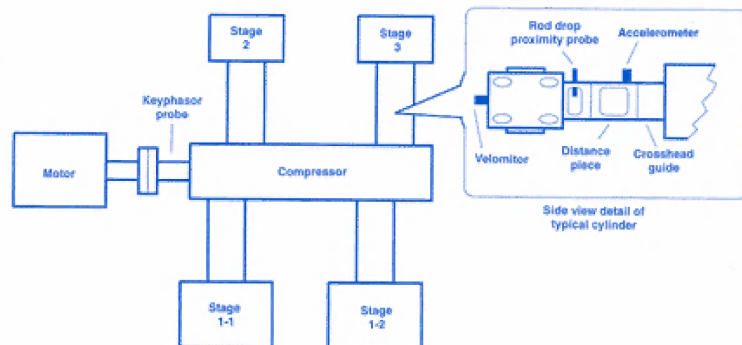
porary accelerometers mounted on each distance piece, rod drop probes installed at the packing box on each piston rod, and Velomitor® velocity sensors located on each cylinder head (Figures 1 and 2). The Velomitor sensor is a piezo-velocity sensor with no

Figure 1  
Overall machine layout, showing transducer locations and orientation.
